An Overview about the Fire Risk Management Culture in the Brazilian Utilities

Abstract: Professional fire safety practice today in the Brazilian electric sector is dominated by traditional regulatory codes, standards and insurance considerations that are based on our past experience, i.e. failures. These methods should be suffice in a simple workplace producing simple and unchanging products or services. However, today's substations are rarely simple and unchanging. Their complexities require a more effective approach to fire safety. A new way of thinking is essential. It should enable us to use the wisdom of past experience and state-of-the-art knowledge in foreseeing fire hazard interactions. The analysis present in this paper focus on the difficulties that transmission sector (i.e. transmission lines and substation) in Brazil has in tackling fire protection. It is hoped that analysis carried out will help designer and engineers shift from a prescriptive fire safety approach to a performance-based one. The intention is also remind the engineers of some idiosyncrasies of fire safety so that they can better plan for them in design.

Key words: Fire; Explosion; Substation; Performa

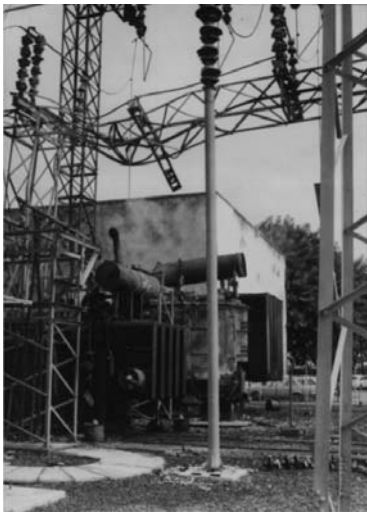
Figure 2 shows the result of a transformer fire. It left the substation unavailable and about one million people on the dark during several hours. Radiation from the fire exposed the steel overhead bus structured to temperature above the yield temperature, causing failure.

Figure 2. Impact of A Transformer Fire on A High Voltage Bus Structure

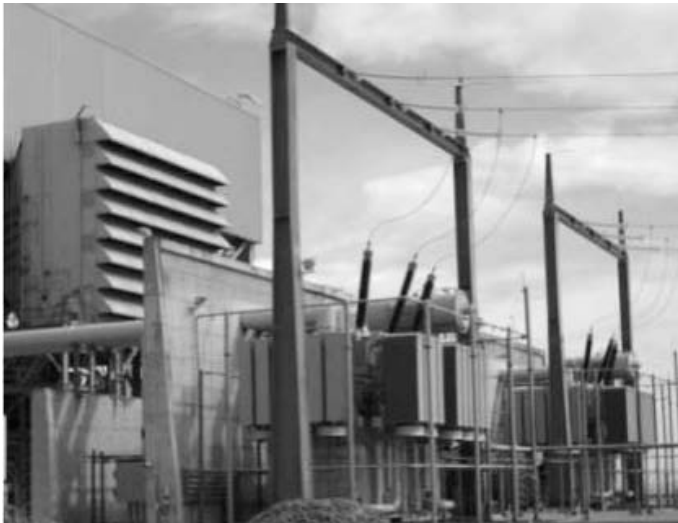
The location of a transformer in the context of a power plant may affect its mission and business objectives if a fire occurs. Some organizations ignore the fire risk in the hope that such an unfortunate event will not happen. Others assume that if a fire does occur, the decision on what to do will be taken at the time. Figure 3 shows the transformer location in the context of a power plant: if a transformer fire occurred in this case, the combustible products could flow into the turbine inlet system.

Figure 3. Detail of Thermoelectric Power Plant Layout

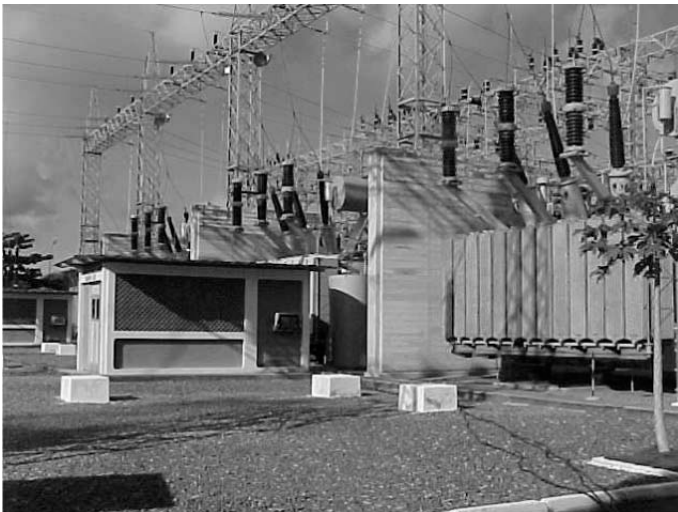
Many transformers have been fitted with water-spray systems to combat the effects of fire, but these systems only serve to limit collateral damage in the substation and cannot prevent initial fire. The fire safety aspects of the installation are also neglected at the design stage. Fire risk analysis of the layout of several substations has unequivocally shown that, when there is some fire protection, its effectiveness is questionable, because it was introduced in isolation from the rest of the system. Figure 4 shows details of the layout of a 230/69 kV substation. This substation was initially designed, constructed and operated for some years without firewalls. Firewalls were constructed at a later stage, probably because a transformer fire in another substation without firewalls destroyed the transformer adjacent to the one on fire. As firewalls exist to protect adjacent transformers in the event of one catching fire or exploding, firewall failure may result in the loss of additional transformers. Although the firewalls were designed to resist fire for 4 hours, studies conducted by Duarte et al [1] showed that they can start to collapse after just one hour. In Figure 5, the grey area shows that the structural integrity of the firewall was compromised, since compressive and tensile stress exceeded the values of 150kg/cm^2 and 15kg/cm^2 respectively.

Figure 4. Detail of Substation Layout

For the substation shown in Figure 4, it is also important to note the relay houses. Some of the protection, bypass and control circuits that control the transformers and other substation equipment are installed in the relay house. In this particular substation there are two relay houses whose structure is masonry with glass windows. A structural thermal performance simulation of one of the relay houses during a transformer pool-fire was carried out using the finite elements method. The distance between the transformer and the relay house was 3.50 meters. Ninety minutes after the fire started, the wall temperature distribution showed some wall temperatures to be above 300°C. Although such high temperatures can cause wall failure, the structural integrity of the walls, pillars and beams was maintained for 117 minutes after the fire started. 45 minutes after the fire started, the glass windows would break, so there would be a rapid increase in the gas temperature inside the relay house. The heat impact would cause irreversible damage to the electronic panels. Analysis of gas temperature distribution inside the house showed that temperatures higher than 70°C would be reached in approximately 30 minutes.

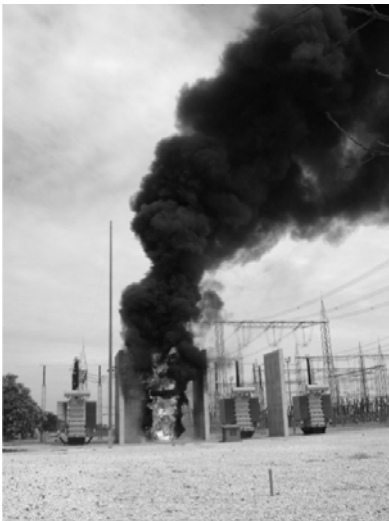
- 2) Radiation from the fire exposed the steel overhead bus structure to temperatures well above the yield temperature, causing failure.
 - 3) An insulating oil pool fire created a very large fire plume. Due to high wind speeds, the fire plume tilted significantly and exposed adjacent equipment, buildings and other structures, as well as causing significant soot deposits in the downwind plume area (Figure 7).

Figure 7. Fire Plume from a Reactor Fire
